RESEARCH AND DEVELOPMENT TECHNICAL REPORT  
CORADCOM- CONTRACT # DAAB07-77-C-2681  
ITT PROJECT # 36015

# LOW COST FIBER OPTIC CABLE ASSEMBLIES FOR LOCAL DISTRIBUTION SYSTEMS

**ITT** *Electro-Optical Products Division*

**FINAL REPORT FOR PERIOD  
MAY 25, 1977 TO OCTOBER 30, 1978**

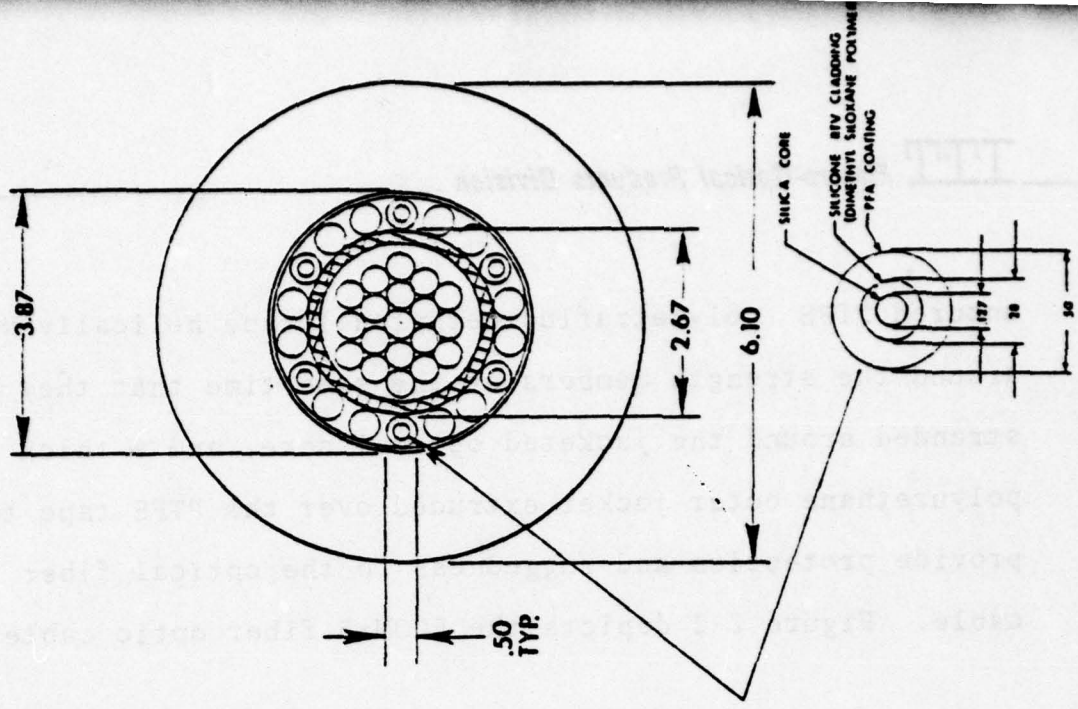
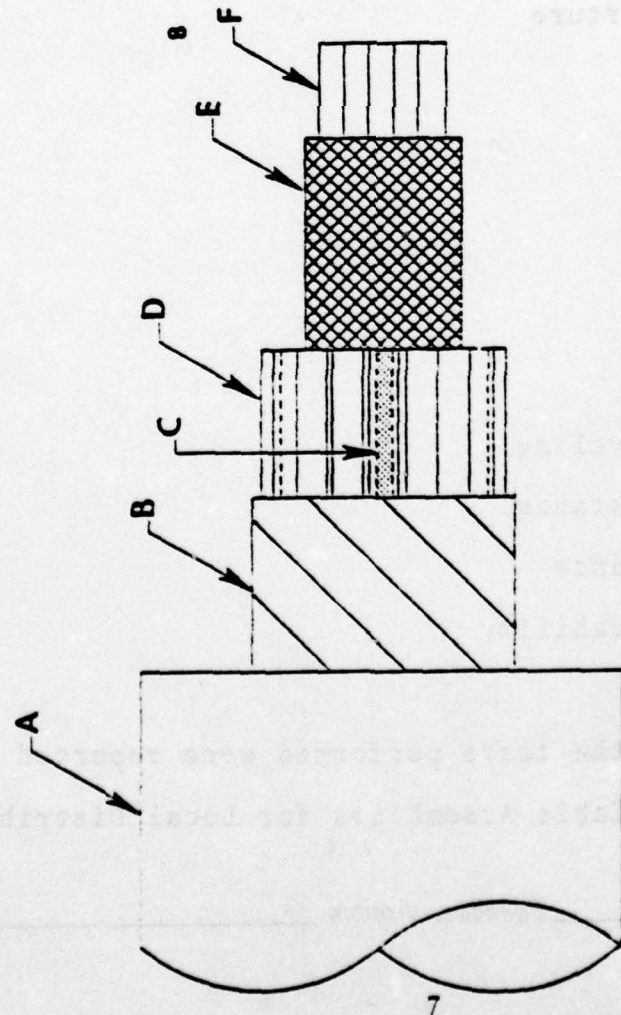
ECOM-1 fiber optic cable design consists of a central strength member surrounded by six optical fibers, helically laid and spaced with two polyester fillers between each two adjacent fibers. This optical core is wrapped with an uncured PTFE tape, which keeps the cable components in the desired position before the outer polyurethane jacket is extruded on the cable. Figure 2-1 depicts the ECOM-1 low cost fiber optic design.

- A - POLYURETHANE JACKET
- B - TFE TAPE
- C - PLASTIC CLAD SILICA FIBER (LAY LENGTH 4.2")
- D - POLYESTER FILLER LAY LENGTH 4.2"
- E - KEVLAR<sup>®</sup> 29 BRAID
- F - KEVLAR<sup>®</sup> 49 STRENGTH MEMBER

CENTRAL STRENGTH MEMBER-SINGLE LAYER DESIGN

ECOM-1

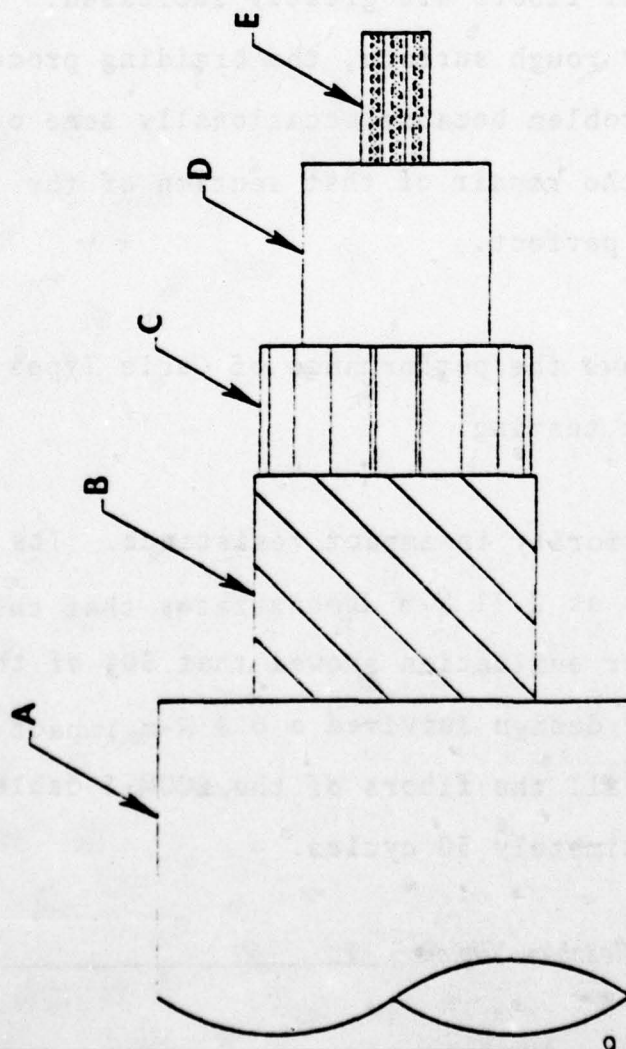
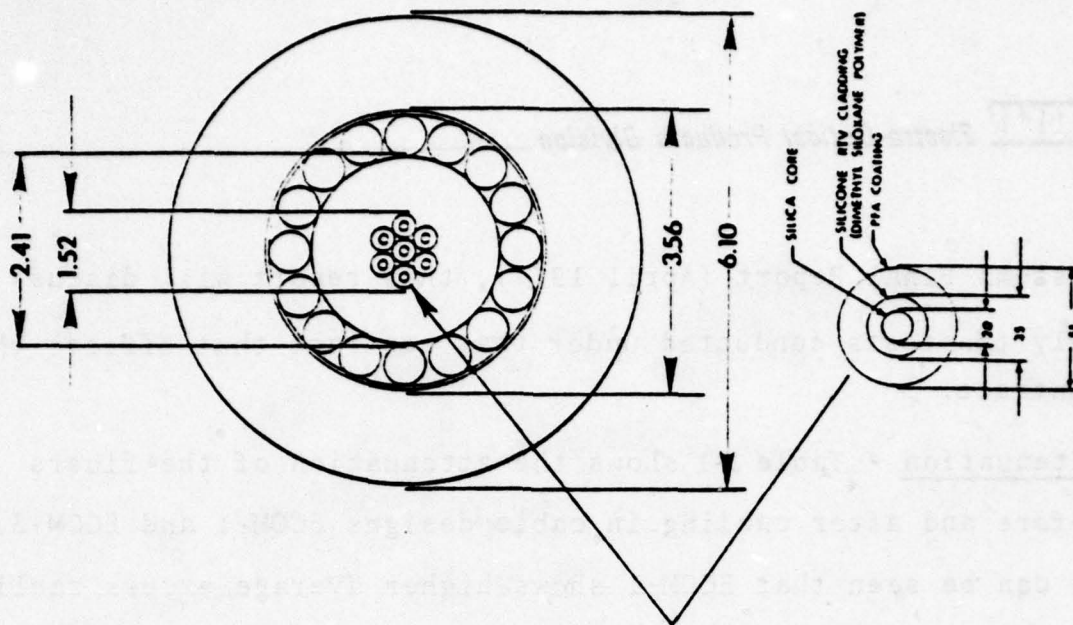
Figure 2-2

ECOM-3 fiber optic cable design consists of an optical core formed by seven helically laid fibers covered with a thin polyurethane jacket, eighteen yarns of Kevlar 49 (1420 deniers) helically laid around the jacketed optical core, an

- A - POLYURETHANE OUTER JACKET
- B - TFE TAPE
- C - HELICALLY LAID KEVLAR™ 49 STRENGTH MEMBER YARNS (LAY LENGTH 4.2")
- D - POLYURETHANE INNER JACKET
- E - OPTICAL FIBER BUNDLE (LAY LENGTH 2.0 )

## EXTERNAL STRENGTH MEMBER DESIGN ECOM-3

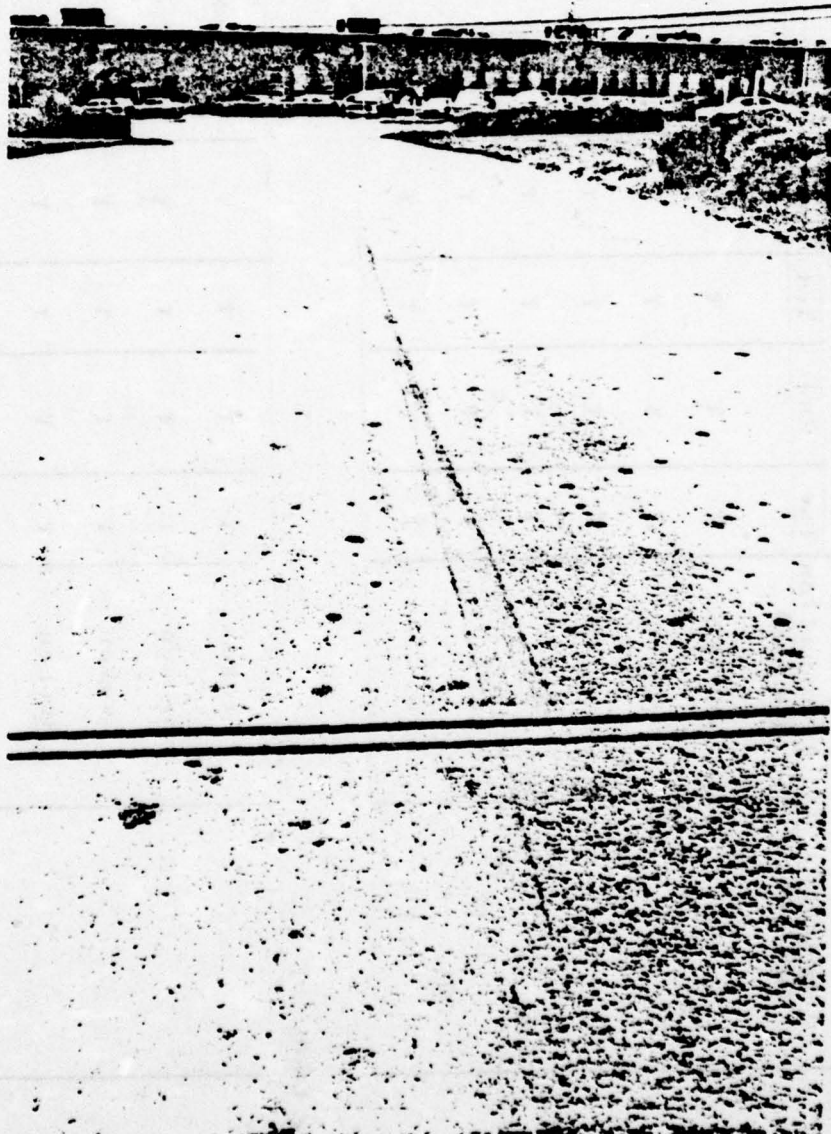
Figure 2-3  
Roadway Survival

All the fibers of both designs survived the first two weeks without fiber damage. One fiber of the ECOM-1 cable ceased transmitting in the third week. An inspection of the testing site showed tire tracks due to intentional acceleration over the cables (See Figure 2-3). However, the ECOM-3 cable had all the fibers transmitting.

Except for the broken fibers, there was no visible damage to either cable.

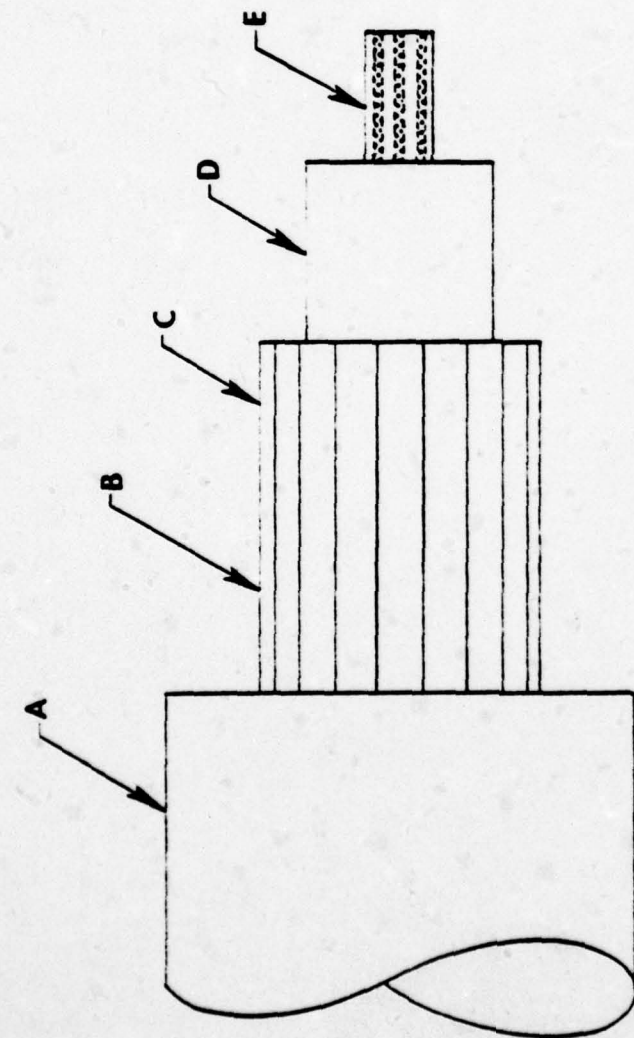
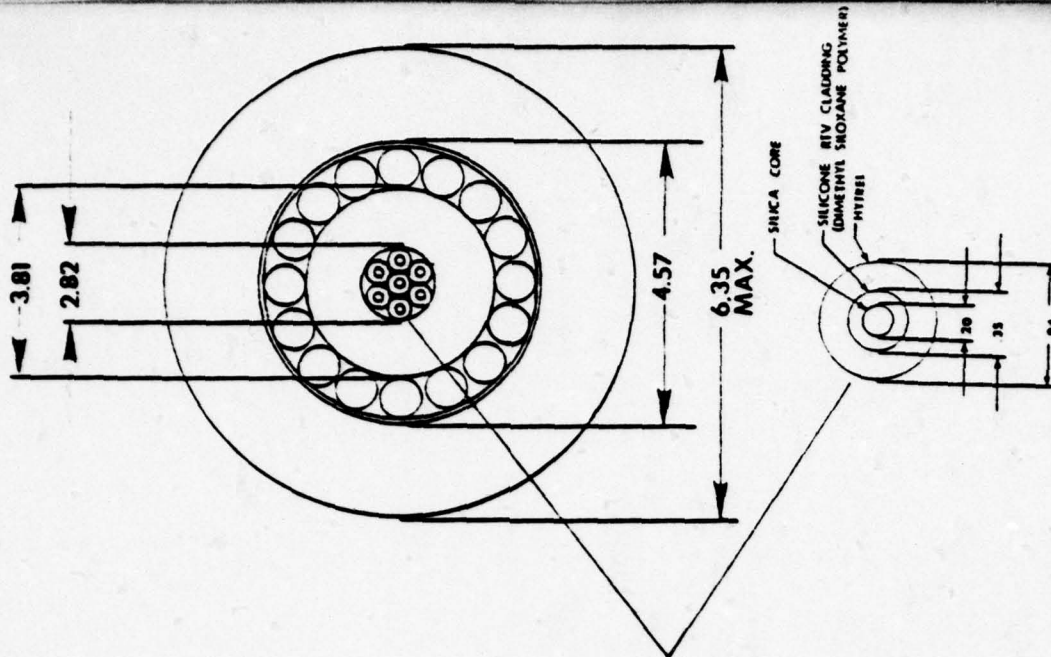
This cable has sufficient tensile strength to meet or exceed the requirement in the technical guidelines.

- A- POLYURETHANE OUTER JACKET
- B TFE TAPE
- C- HELICALLY LAID KEVLAR 49 STRENGTH MEMBER YARNS (LAY LENGTH 4.2")
- D- POLYURETHANE INNER JACKET
- E - OPTICAL FIBER BUNDLE (LAY LENGTH 2.0')

## OPTIMIZED LOW COST FIBER OPTIC CABLE

Since the ECOM-3 design had better optical performance than the ECOM-1 design, it was selected for mechanical optimization. It was found that the heavier buffer of the optical fiber was a major factor in achieving the specified cable parameters. One millimeter fibers were selected for this task because of their compatibility with existing connectors.

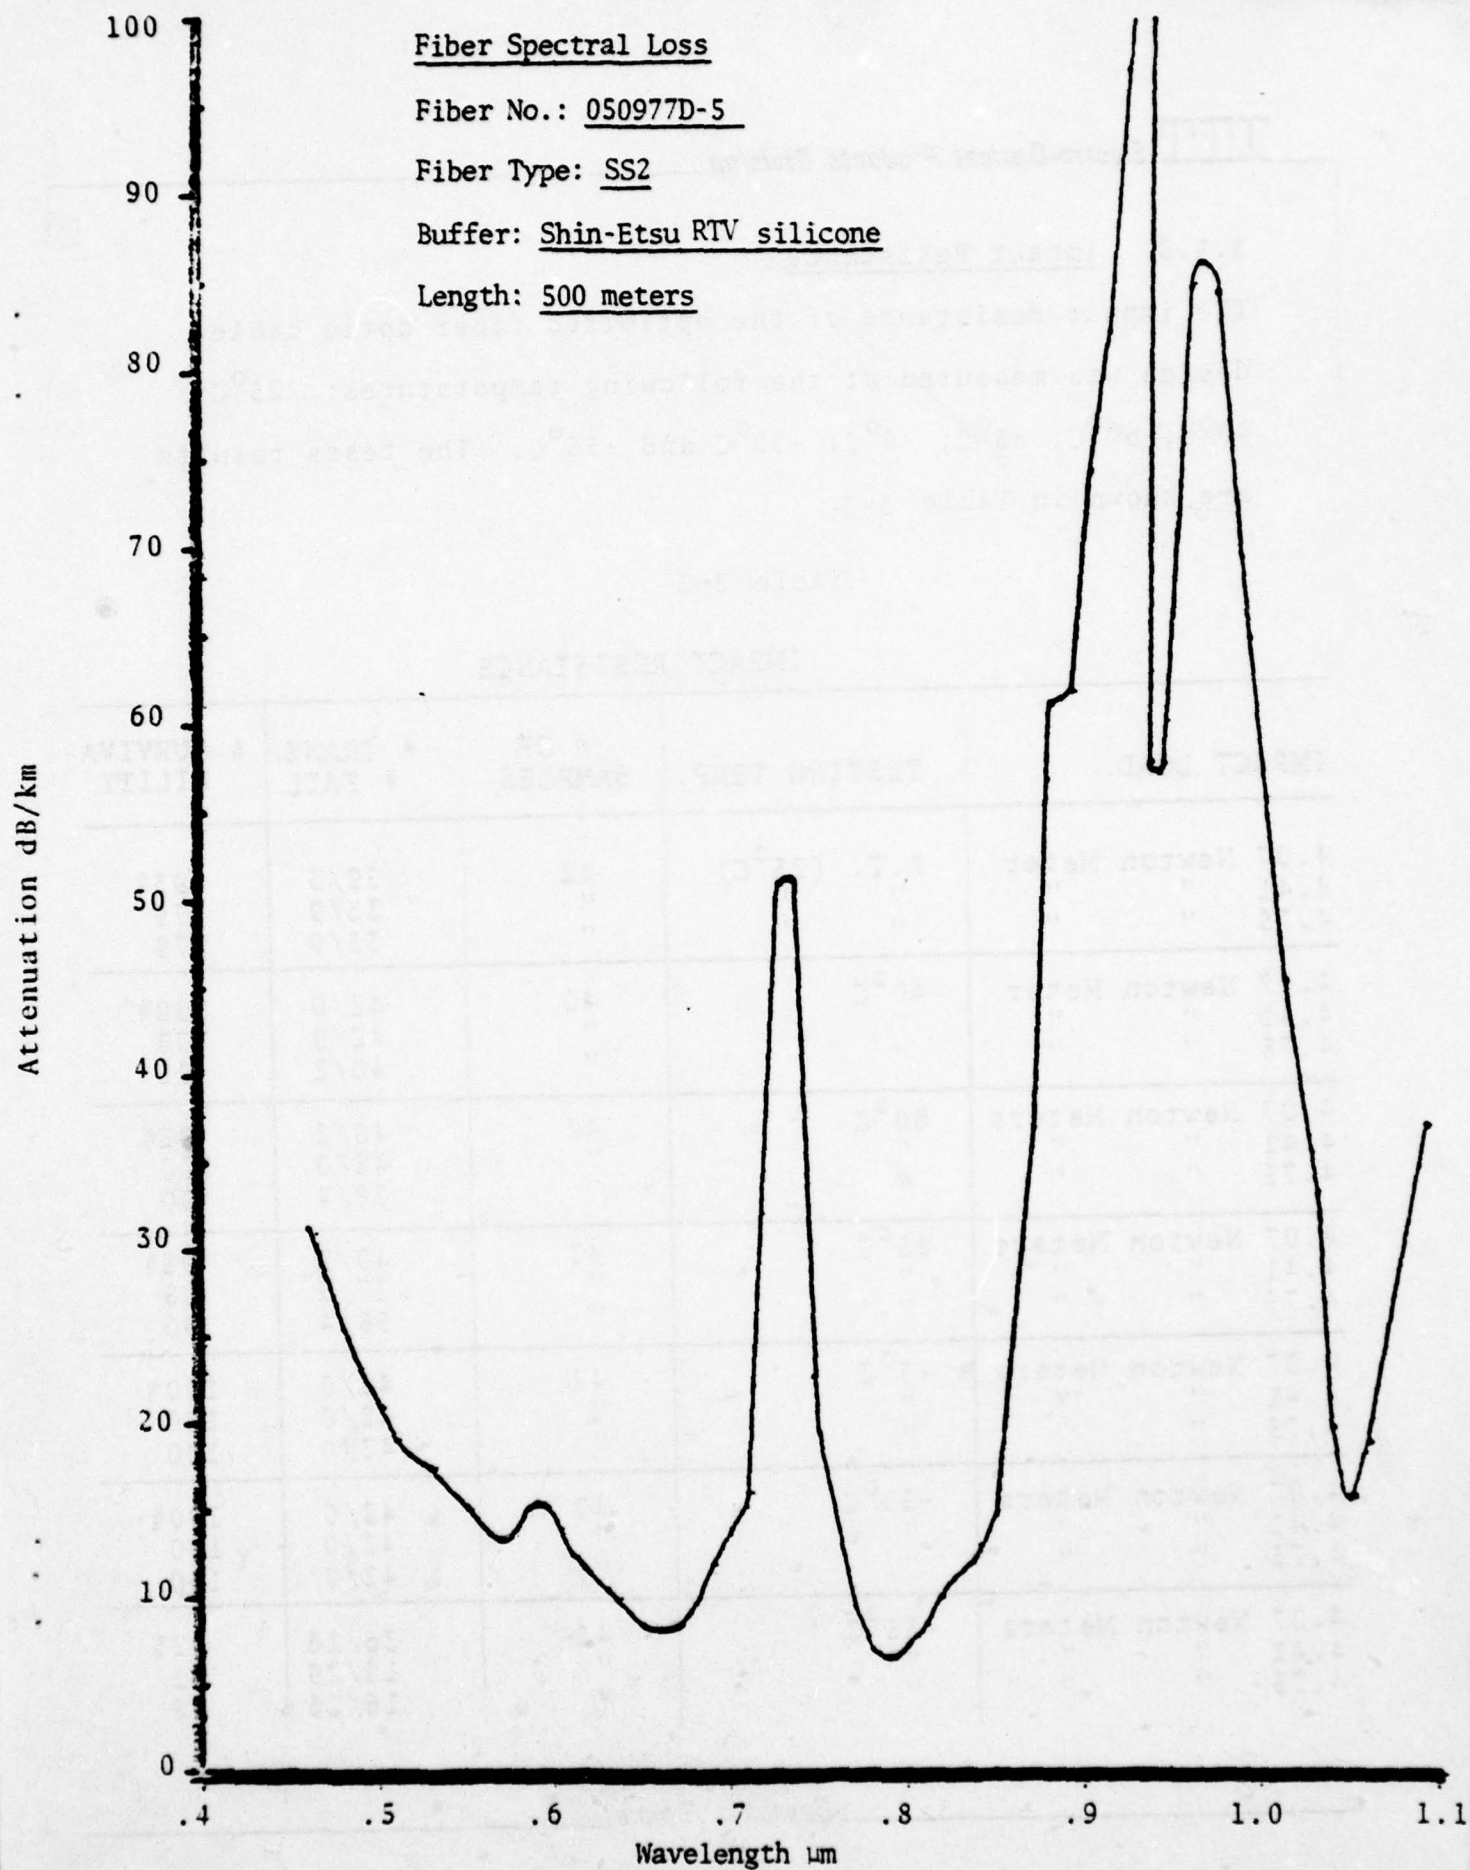
Figure 3.1 Plastic Clad Silica Optical Fiber
